Mobile Intel[®] Pentium[®] II Processor Specification Update

Release Date: July 2001

Order Number: 243887-032

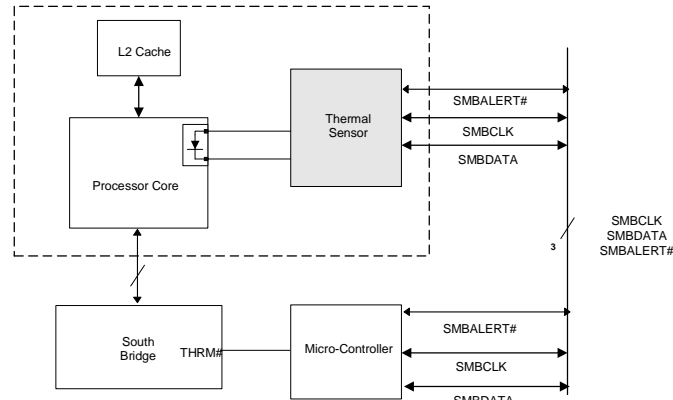
Figure 1. An Example of Microcontroller Driven Thermal Management

B30. Thermal Sensor May Assert SMBALERT# Incorrectly

Problem: The Mobile Pentium II processor and the Pentium II Processor Mobile Module have a thermal sensor that monitors the processor core's temperature. Please note that desktop systems could have a similar thermal device. The thermal sensor asserts SMBALERT# if the processor temperature exceeds the temperature limits set in the Alarm Threshold Registers (T_{HIGH} , T_{LOW}). It also sets the corresponding Status Register bits to identify the cause of the interrupt. Figure 1 gives one example of the how the SMBALERT# signal could be used in a system.

Under the conditions described below, the thermal sensor incorrectly generates the SMBALERT# interrupt. All of the following conditions must be met to trigger a false interrupt:

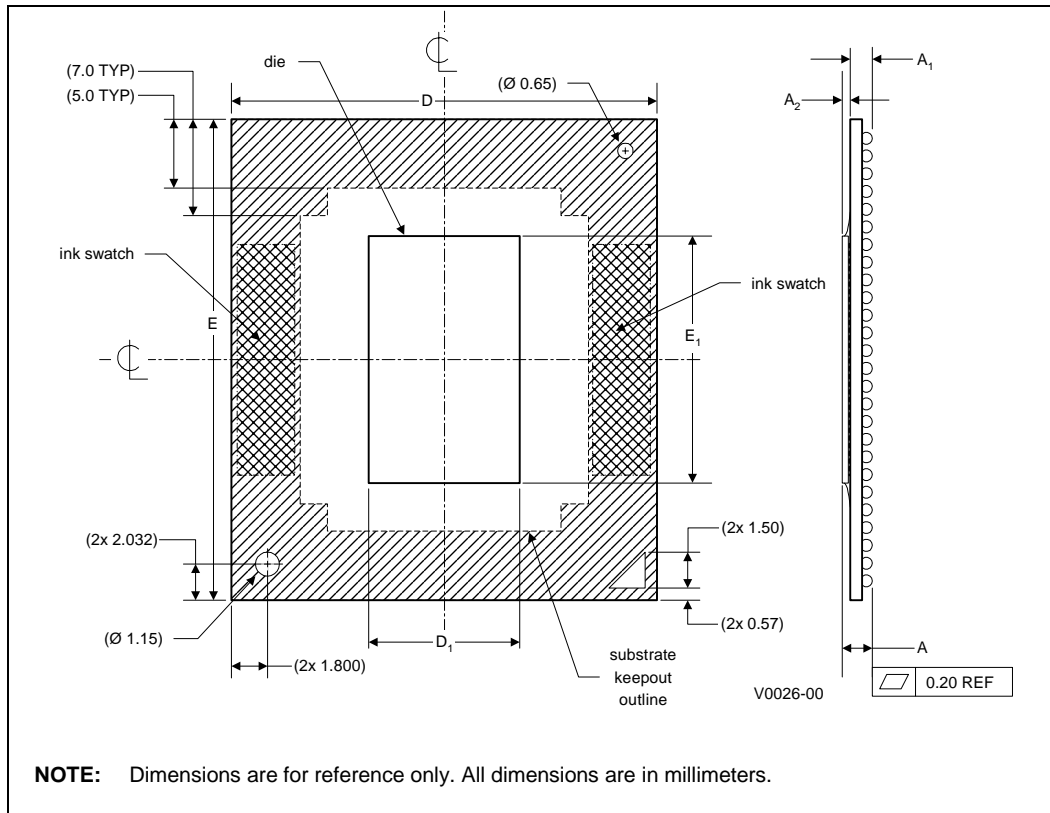
Figure 5.3. Surface-Mount BGA1 Package—Top and Side View

The following table and figures show the updated mechanical specifications for the BGA1 package, listed as Table 5.2, Figure 5.3 and Figure 5.4, respectively, in the *Mobile Pentium® II Processor in BGA Package at 366 MHz, 333 MHz, 300PE MHz, and 266PE MHz* datasheet.

1. The number shown here is different from that in the 243887-010 revision of this specification update. The maximum reference number is used.

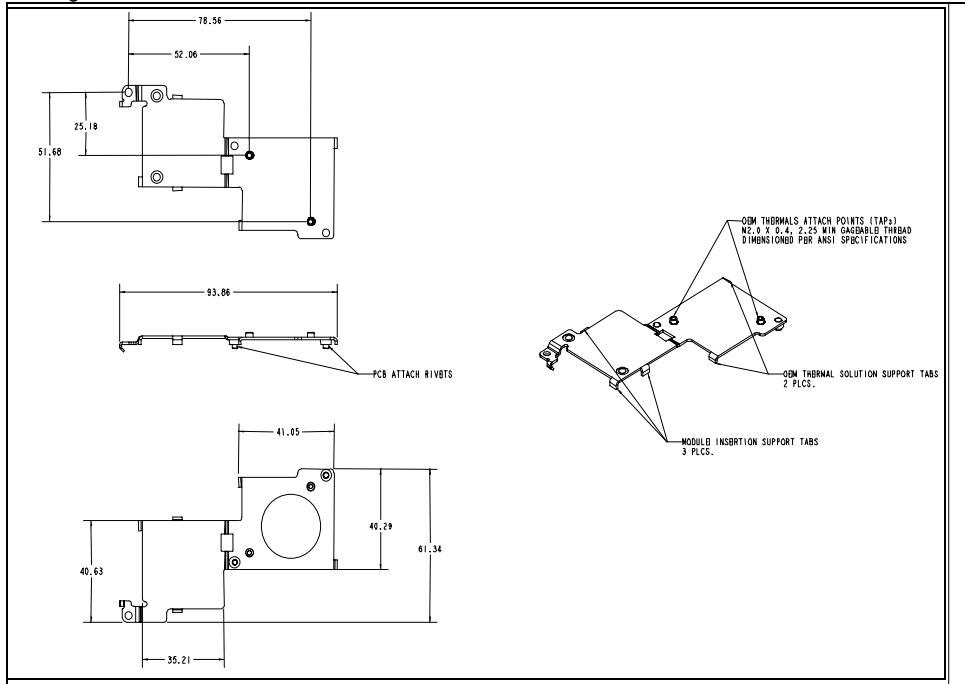
Figure 1. TAP Gageable Thread Clarification

OEM Thermal Attach Points (TAPs) M2.0 x 0.4, 2.25 min gageable thread dimensioned per ANSI specification.

See Figure 1 below for more information.
